Protection and Remediation of In-Service Timber Bridges with Field-Applied Preservative Treatments (Phase I)

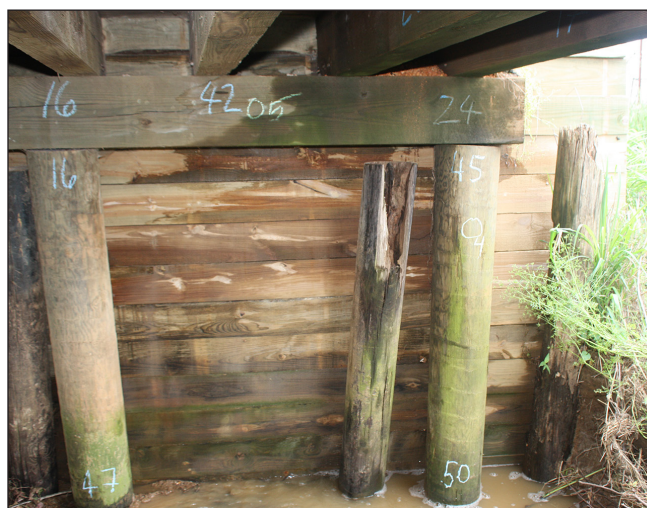
Figure 1. Below-grade photograph of a stringer-type timber bridge on wood piling. The smaller diameter pilings on the right are remnants from a previous (lower capacity) timber bridge. The existing, higher capacity, bridge was installed over the same site as one located there previously.

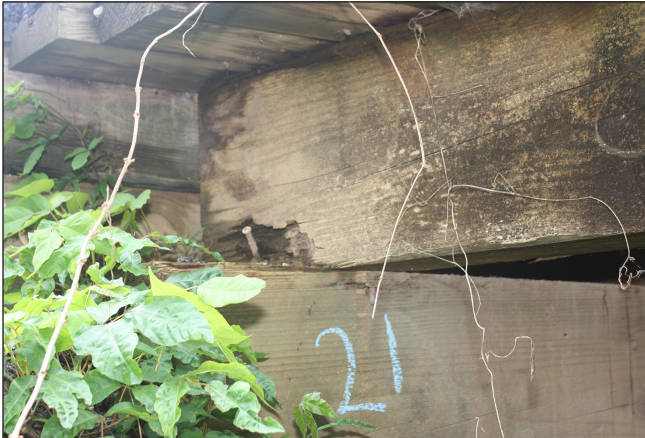
Figure 2. Timber bridge stringer in need of repair or replacement at its end that is sitting on a pile cap.

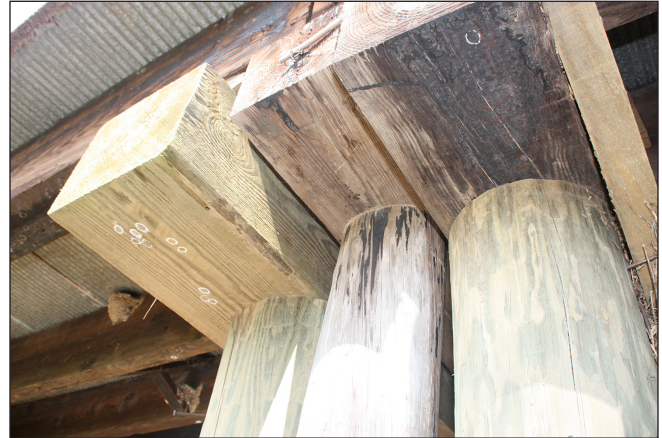
Figure 3. Timber bridge with upgraded capacity. The middle pile and pile cap are original. The left and right piles and caps were added later as a means of upgrading bridge capacity.
